Static and Fatigue Testing of Mechanical Life Extension Options for Plates Containing Elongated Holes

R. L. Evans and M. Heller DSTO-TR-1202

Airframes and Engines Division Aeronautical and Maritime Research Laboratory

DSTO-TR-1202

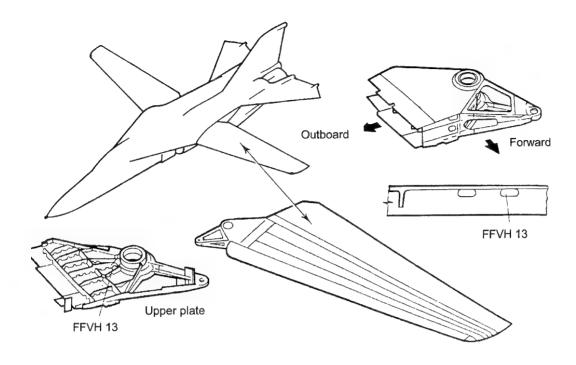
Figure 1. F-111 aircraft and wing showing the location of fuel flow vent hole number 13 (FFVH 13) in the wing pivot fitting (WPF).

The wing pivot fitting (WPF) is a primary structural component in the F-111 wing and has been the site of fatigue cracking in service and structural failures during cold proof load testing (CPLT)¹. The WPF assembly, as shown in Figure 1, consists of an upper and lower plate with integrally forged stiffeners, which are welded together to form a box structure which transmits concentrated wing loads through a pivot pin. It is made of high strength D6ac steel that has low fracture toughness, hence it is sensitive to fatigue cracking in areas of high stress concentration. The main locations at which cracks have occurred are geometric features in the WPF upper plate stiffeners, known as fuel flow vent holes (FFVHs) and stiffener runouts (SROs). In terms of the FFVHs, the most frequent location of cracking has been at FFVH 13, however cracks have also been detected at FFVH 11, 12 and 14.

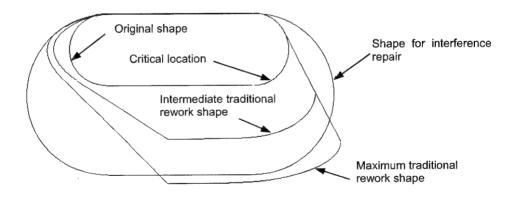
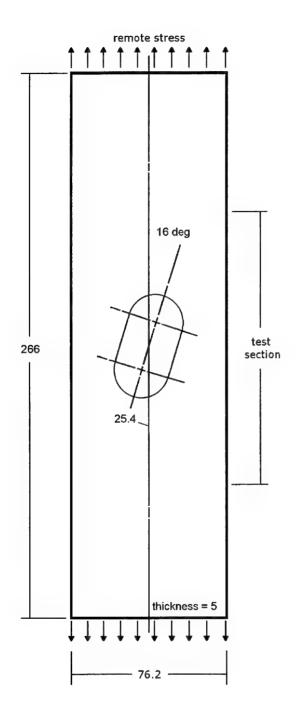
Figure 2. Comparison of the original (i.e. blueprint) geometry of FFVH 13 with typical RAAF rework shapes and proposed hole for interference-fit plug.

regular precautionary process called confidence polishing². However, these non-precise procedures have generally resulted in a large range of ill-defined FFVH shapes in the F-111 fleet. For the removal of 'long' cracks, AMRL developed a family of rework shapes for FFVH 13, [3]. Such a typical intermediate rework shape is shown in Figure 2. These shapes primarily addressed the stress concentration at the lower inboard corner of FFVH 13 by increasing the radius of curvature at that location, with the intention of reducing the peak residual tensile stress as well as the cyclic stress at this location. Fleet wings were reworked to a member shape of this family when a 'long' crack was detected in maintenance (small cracks were blended out by hand applied abrasion). A member shape was selected that was just large enough to completely remove the crack. The rework was manufactured using electro-discharge machining. It has been demonstrated by FE analysis and full-scale test that the family of standard FFVH 13 rework shapes gives a reasonable stress reduction at the critical lower inboard corner location. Unfortunately, the recent DADTA results, mentioned above, show that the stress reduction is not sufficient to produce an acceptable inspection interval. Also, there has been a recent instance of a crack at FFVH 13 in an F-111C wing, despite a rework shape similar to that shown in Figure 2 having been implemented previously in that wing3. These circumstances indicate that the current management strategy for FFVH 13, using the current rework shapes, is not sufficient to provide both an acceptable safe inspection interval and sufficient durability to the PWD.

For the interference-fit plug option there has been a significant degree of prior work. The concept is to accurately machine a non-circular hole to a size similar to the maximum AMRL rework shape as shown in Figure 2, for subsequent cold-expansion and interference-fitting. This would allow the repair to be applied to most holes in the fleet, irrespective of their current shape. The ability to cut such a hole with a high degree of accuracy has been demonstrated on an actual F-111 wing in prior work at AMRL, [6]. Here an advanced electro-discharge machining procedure was used. It is worth noting that interference fitting and/or cold expansion of circular holes are highly effective and well-known approaches [7, 8, 9], whereas the non-circular case is a relatively new concept. Two-dimensional finite-element analyses have recently been used to investigate the typical stresses for the non-circular hole enhancement [10, 11]. This work indicated that enhancement through combined cold expansion and interference fitting should be considerably better than interference fitting alone. Also in this work, plate stress distributions measured experimentally due to elastic interference-fitting to a level of approximately 0.74%, compared well with the finite-element predictions. This demonstrated the suitability of a proposed AMRL tapered plug/sleeve design to achieve effective elastic interference-fitting of an elongated hole. Cold-expansion testing of non-circular elongated holes using this proposed plug has also recently been undertaken [12]. Nominal expansion levels of greater than 2.5% were achieved along with maximum peak strains of more than 10,000 με and maximum residual strains of greater than 1600 µE, indicating highly effective cold expansion. It was also demonstrated that subsequent to cold expansion, interference fitting could be achieved without the need for post cold-expansion machining. Fatigue testing of the plug/sleeve assembly (with minor design revisions) was recommended to confirm its suitability as a highly effective option for extending the fatigue life of the FFVH 13 region of the F-111 aircraft.
